FACILITY COMPLIANCE INSPECTION REPORT

City of Durham LCID Landfill
 1833 Camden Avenue
 Durham, NC 27704

Post Closure Audit

Digital pictures taken February 14, 2012
by John Patrone, DWM-SWS

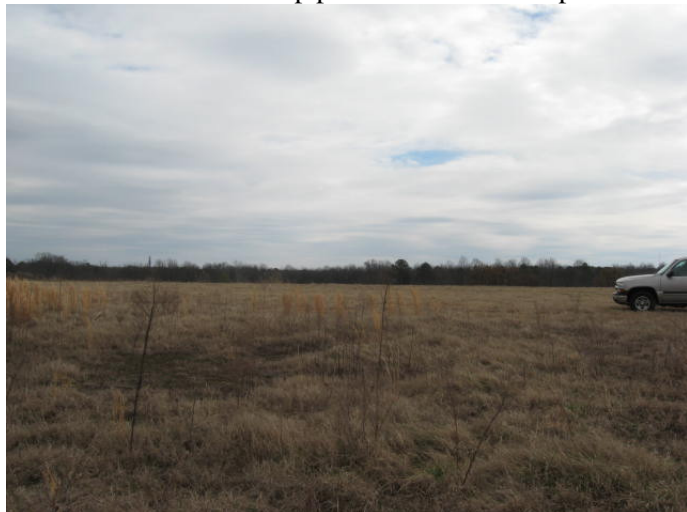
Phase II – view across top portion of landfill cap

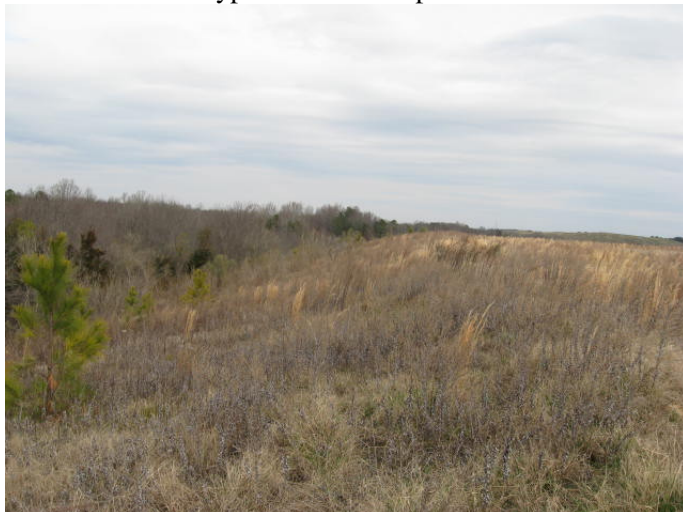
5. The LCID landfill side slopes appeared to be graded to a 3:1 ratio.
6. The facility annual report (FAR) received by the SWS is dated 07/25/11. The facility did not operate.

Phase II – view typical of side slope

2. The facility is located adjacent to the City of Durham Solid Waste Management Department (office building).
3. The landfill cap is covered with native vegetation and mowed twice a year, in the spring and fall. Ensure the LCID landfill side slopes are routinely mowed.

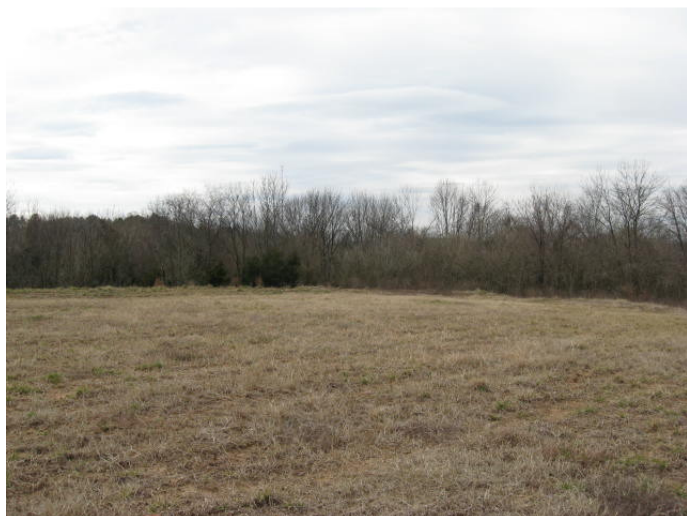
Phase I – view across top portion of landfill cap

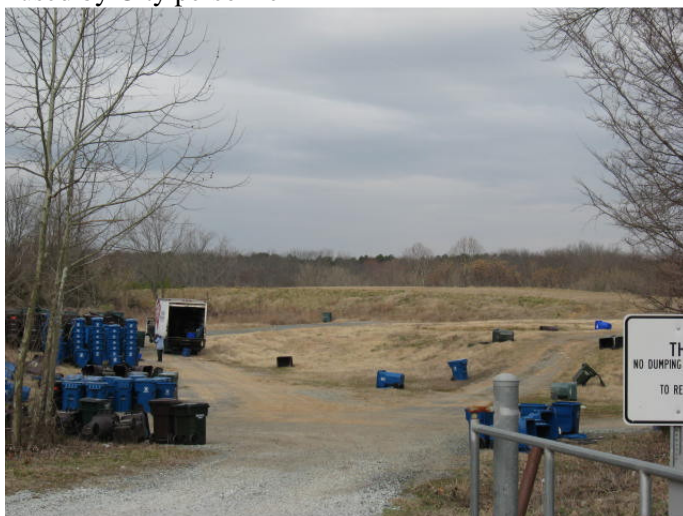
13. Ensure that the facility identification number is posted at the entrance.
14. The site is secured by a locked metal gate. The gate is kept open during workdays for City of Durham personnel to access the property for its container storage area, etc. Mr. Marriott stated that the gate is closed each night and on weekends.

Entrance to facility, portion of landfill property actively used by City personnel
